APPENDIX C: Debris Map

[Editor's note: Debris map and evidence description provided courtesy of J.L.Hall Engineering Services, Inc., Ames Iowa.]

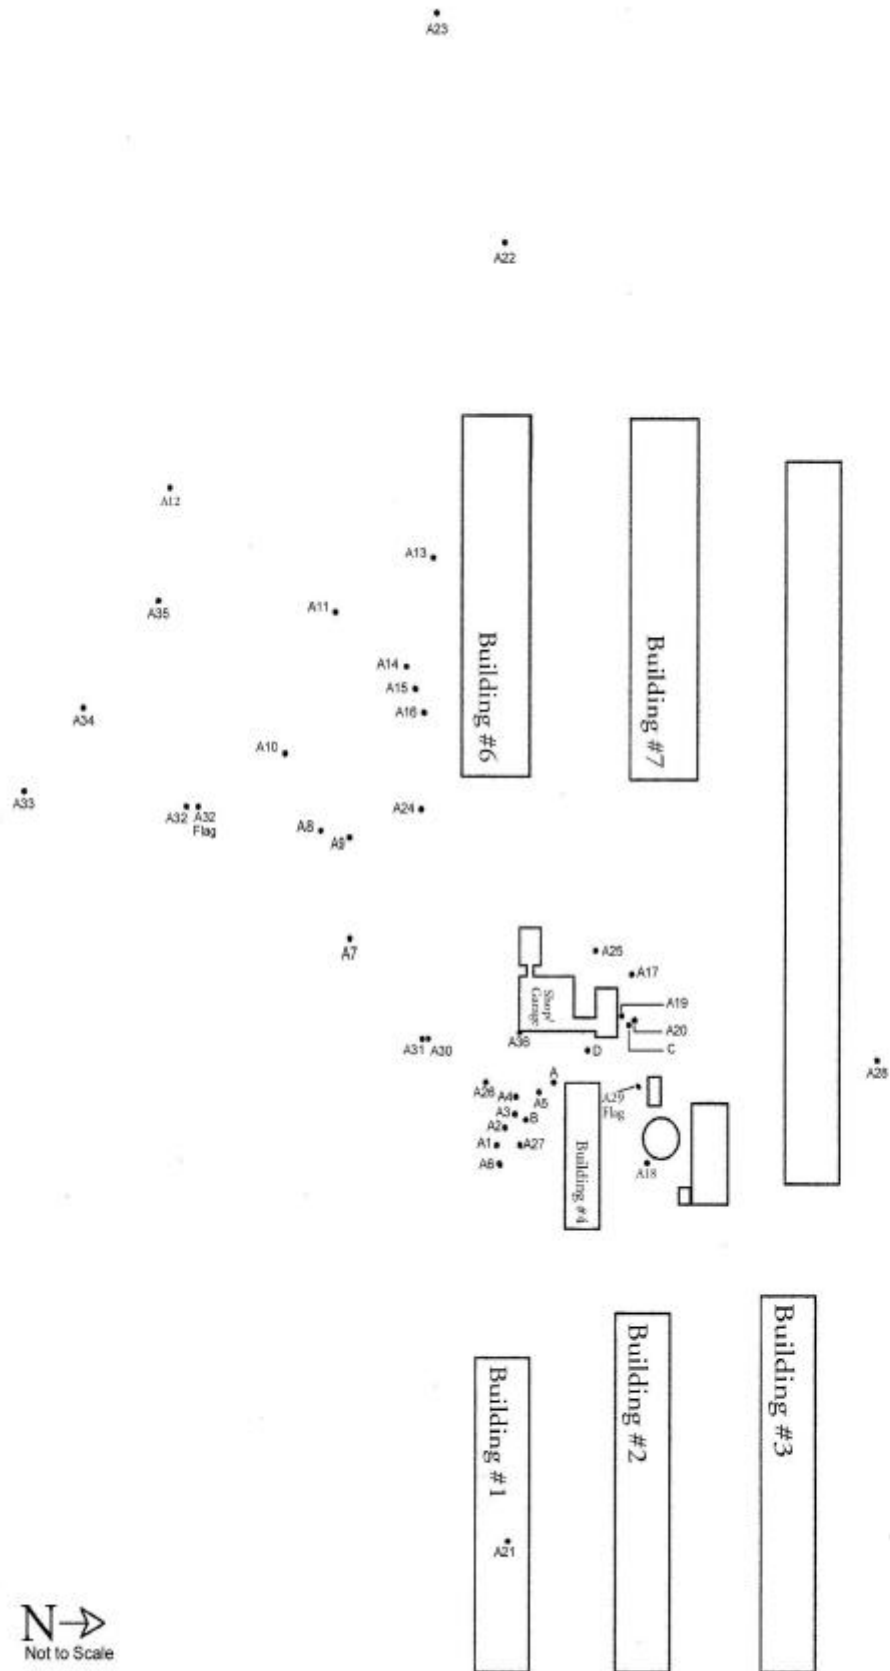
EVIDENCE	DESCRIPTION
A1	3/4" pipe with union and elbow
A2	section of fill piping
A3	section of fill piping 12' 3" long
A4	section of fill piping 5' long
A5	13' 6" piping northwest of explosion
A6	15' piping with elbow near tank location
A7	piece of flat steel
A8	bulkhead Southwest of explosion in field
A9	steel piping in field SW of explosion
A10	spring in field SW of explosion
A11	west end of tank in field SW of explosion
A12	small section of flat steel from tank
A13	section of relief valve riser piping
A14	section of piping with valve west of explosion
A15	manual valve
A16	spring west of explosion
A17	portion of LP tank west of explosion
A18	LP tank section north of explosion
A19	Fisher valve NW of explosion
A20	Fisher valve NW of explosion
A21	large LP tank section east of explosion
A22	steel piping in field west of explosion
A23	steel piping in field west of explosion
A24	section of relief valve riser piping

A25	ladder from tank NW of explosion
A26	fill station and piping
A27	vaporizers and associated piping
A28	section of steel piping north of explosion
A29	float arm from inside LP tank
A30	section of relief valve riser piping
A31	spring located SW of explosion
A32	artifact in field SW of explosion
A33	steel piping in field SW of explosion
A34	cap in field SW of explosion
A35	cap in field SW of explosion
A36	actuator arm for gauge inside LP tank
A	face plate for liquid volume gauge
B	piece of flat steel
C	small LP regulator
D	small piece of tank metal
